**ASX REPORT TO
SHAREHOLDERS**

13 June 2013

Siana operations further update

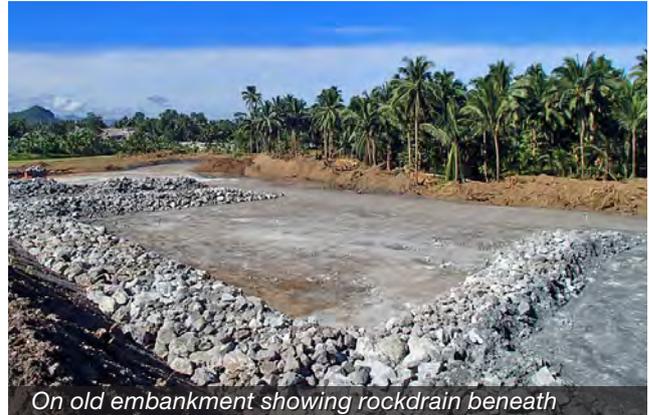
On old embankment showing rockdrain beneath

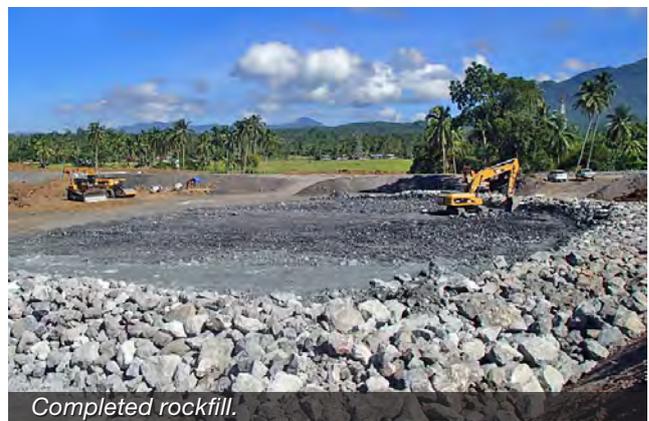
Completed rockfill.

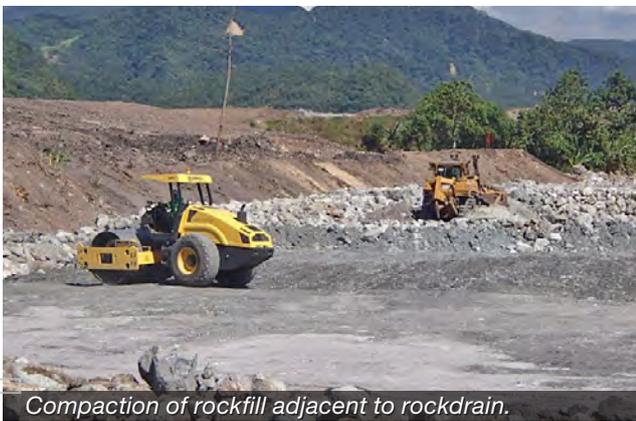
Compaction of rockfill adjacent to rockdrain.

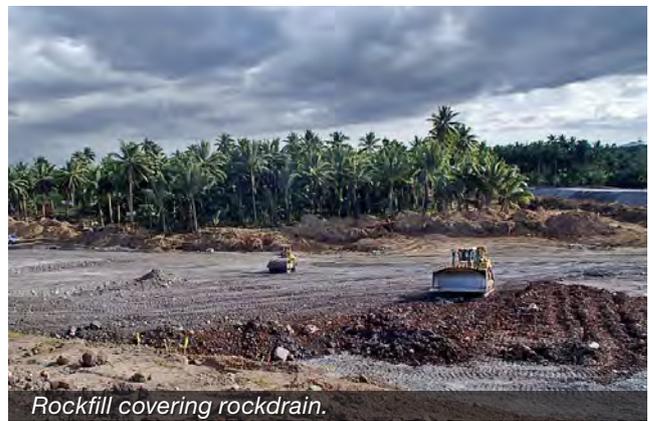
Rockfill covering rockdrain.

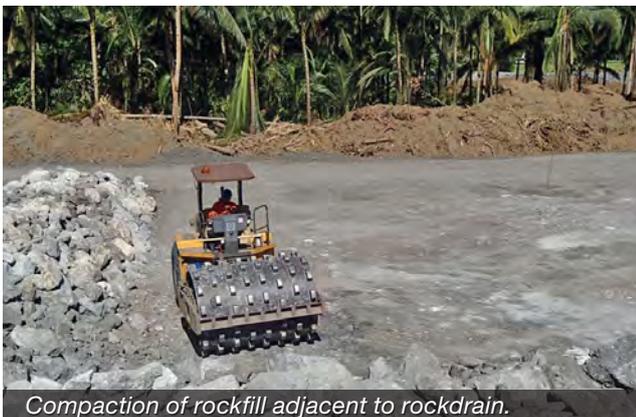
Compaction of rockfill adjacent to rockdrain.

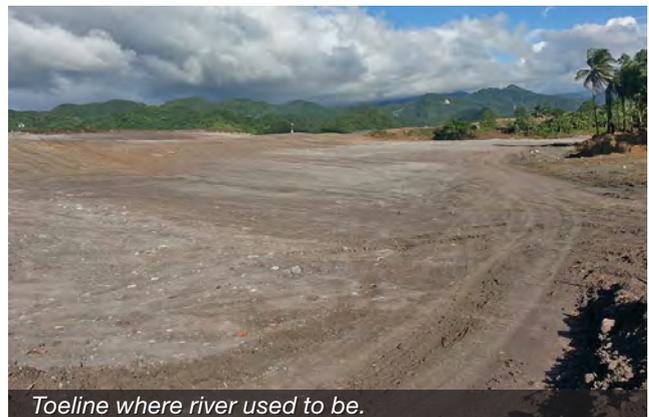
Toeline where river used to be.
